The fire resistance performance of 26 pipe penetration sealing systems, 11 cable penetration sealing systems and a blank penetration sealing system within a cross laminated timber supporting construction, when tested in accordance with BS EN 1363-1: 2012 and BS EN 1366-3: 2009

412849 Revision A

Polyseam Ltd
15 St Andrews Road
Huddersfield
West Yorkshire
HD1 6SB

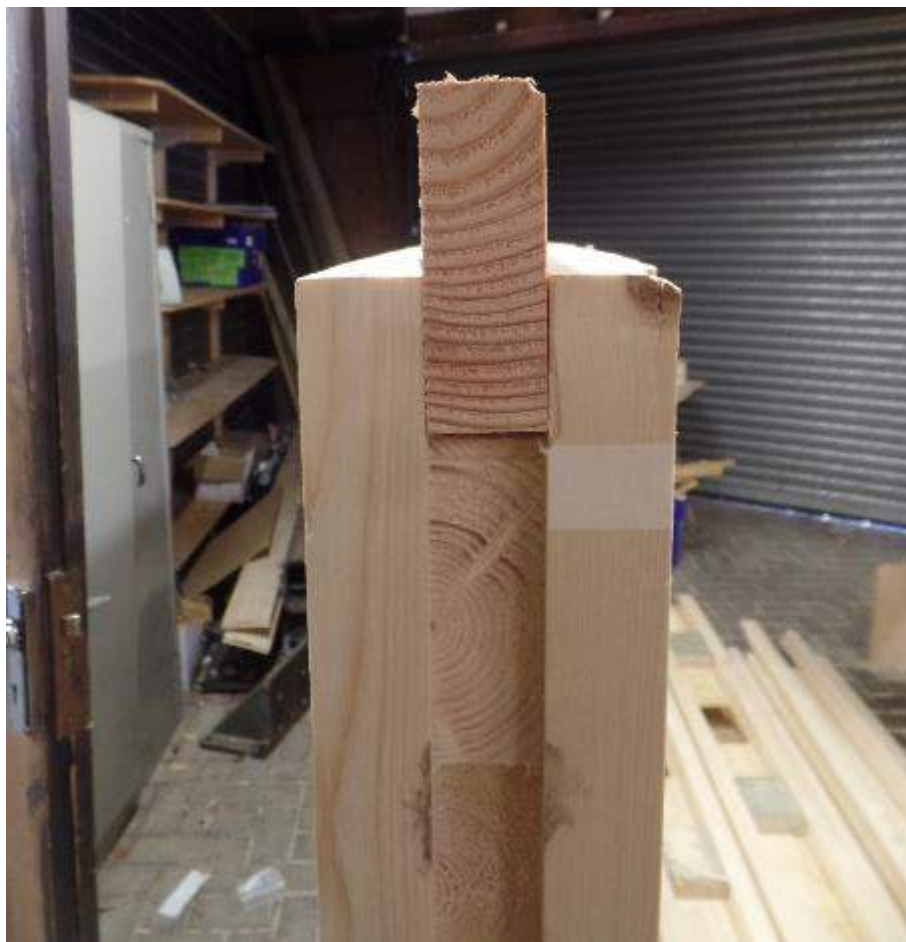
The drawing below displays the dimensions of the loose tongue joint within the wall with the Protecta FR Acrylic nominally 2mm thick between the two sections.

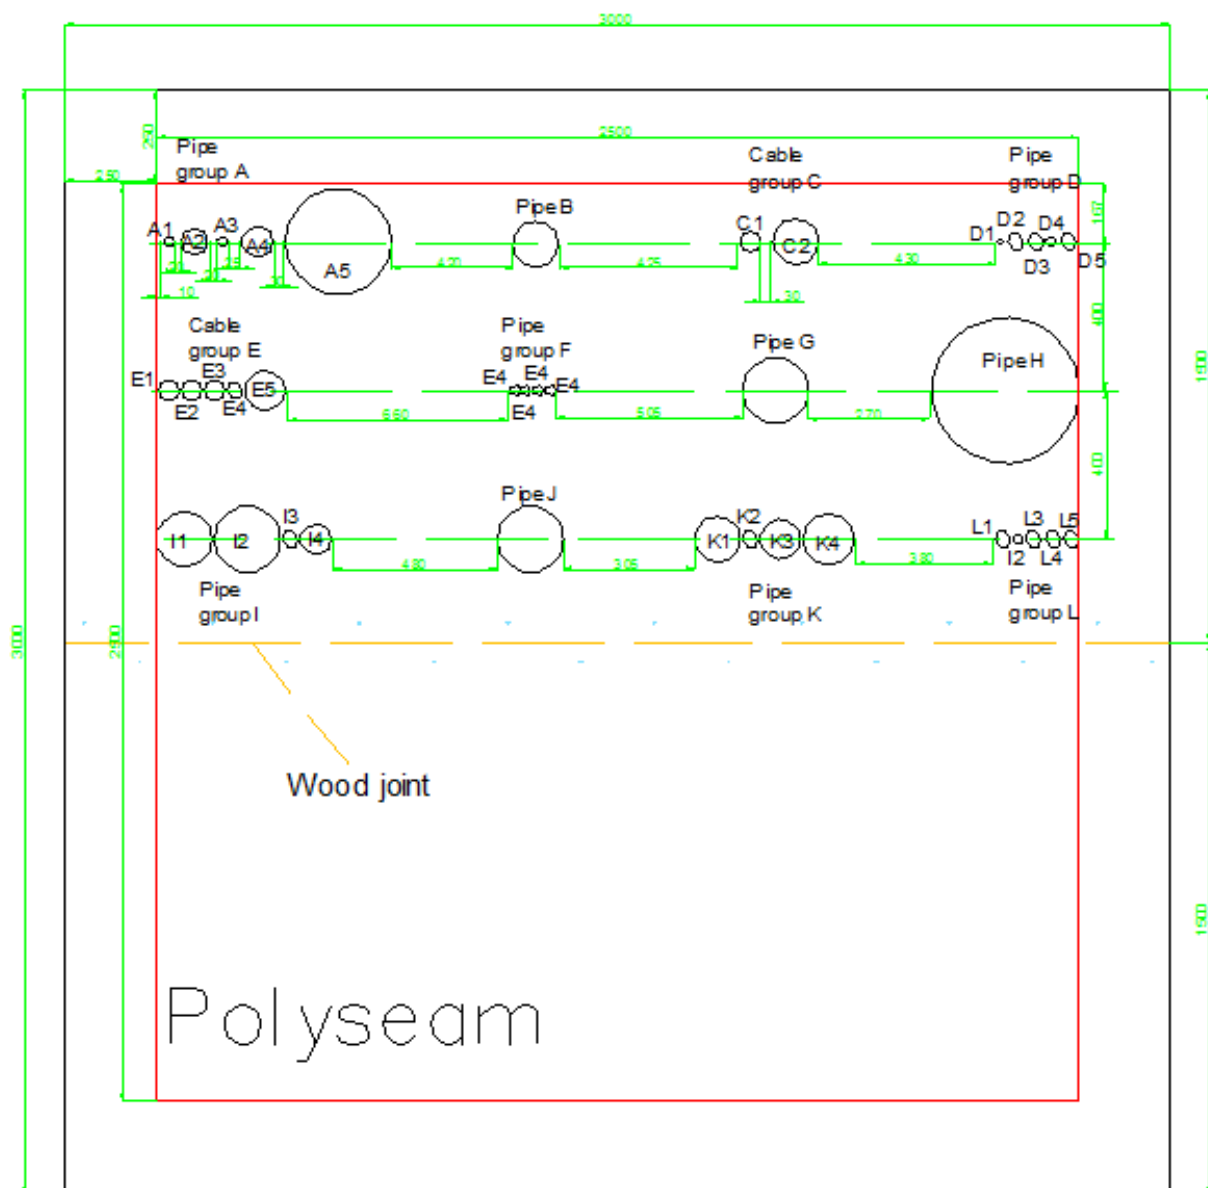
Unexposed view of the wall
(Aperture sizes and distances between)

Position details of the specimens are shown below. All measurements are in mm and the descriptions are written viewing the specimens from the unexposed face unless stated otherwise.

Pipes A1-A5 measured nominally 1500mm long with 650mm protruding from the exposed face.

All remaining pipes and cables measured nominally 1200mm long with a minimum of 500mm protruding from the exposed face.

The pipes A1 – A5, were positioned as per figure E2 option 1 of BS EN 1366-3: 2009 where a_1 measured 10mm and a_2 measured 0mm after the insulation was installed. See section 7 full dimension details.

The transits C1 and C2, were positioned as per figure E2 option 1 of BS EN 1366-3: 2009 where a_1 measured 10mm and a_2 measured 30mm once the insulation was installed:

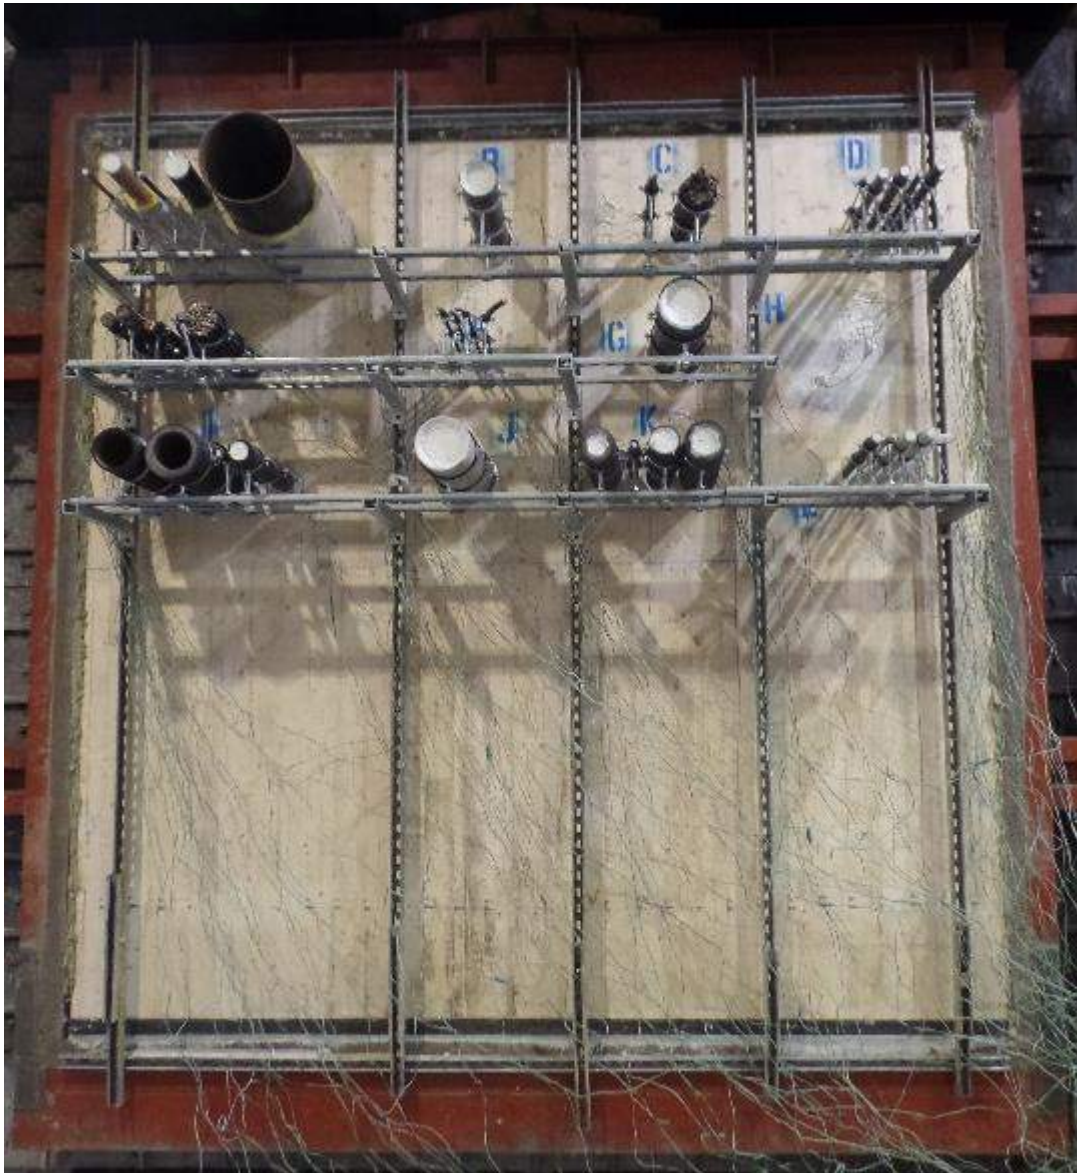
On the unexposed face, 14No. 500mm Unistrut cantilever arm sections provided support for 6No. horizontal lengths of Unistrut and pipe brackets, providing support for the pipes and cables at 250mm and 450mm from the face of the partition, fixed to 5No. vertical lengths of Unistrut fixed to 2No. horizontal lengths of Unistrut fixed to the restraint frame above and below independent from the partition.

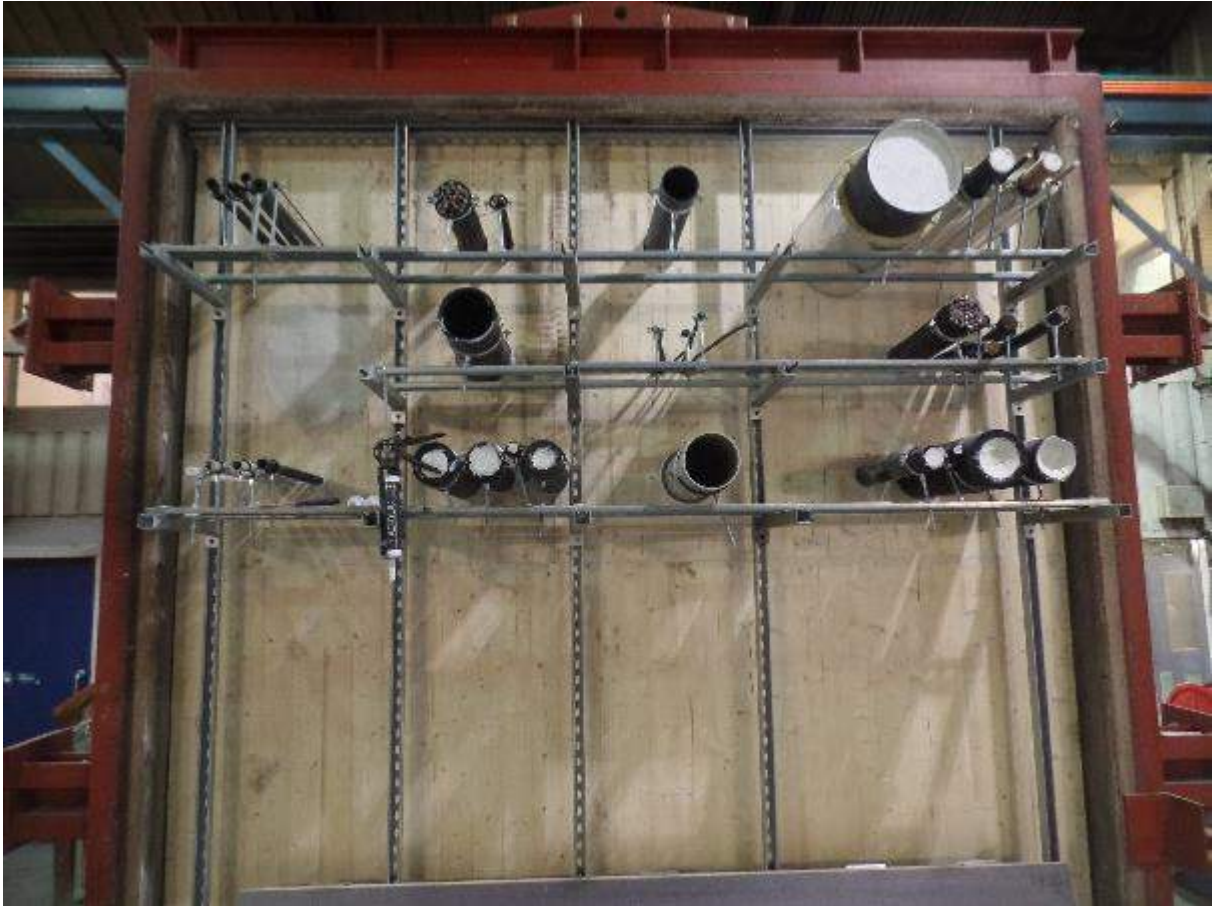
Exposed face penetration reports

On the exposed face, 14No. 500mm long Unistrut cantilever arm sections provided support for 6No. Unistrut 'U' section channels and pipe brackets providing horizontal support for the pipes and cables at 450mm from the face of the partition, fixed to 5No. vertical lengths of Unistrut fixed to 2No. horizontal lengths of Unistrut fixed to the restraint frame above and below independent from the partition.
